**IBM** Customer Engineering

# SERVICES INDEX

# 83

Sorter

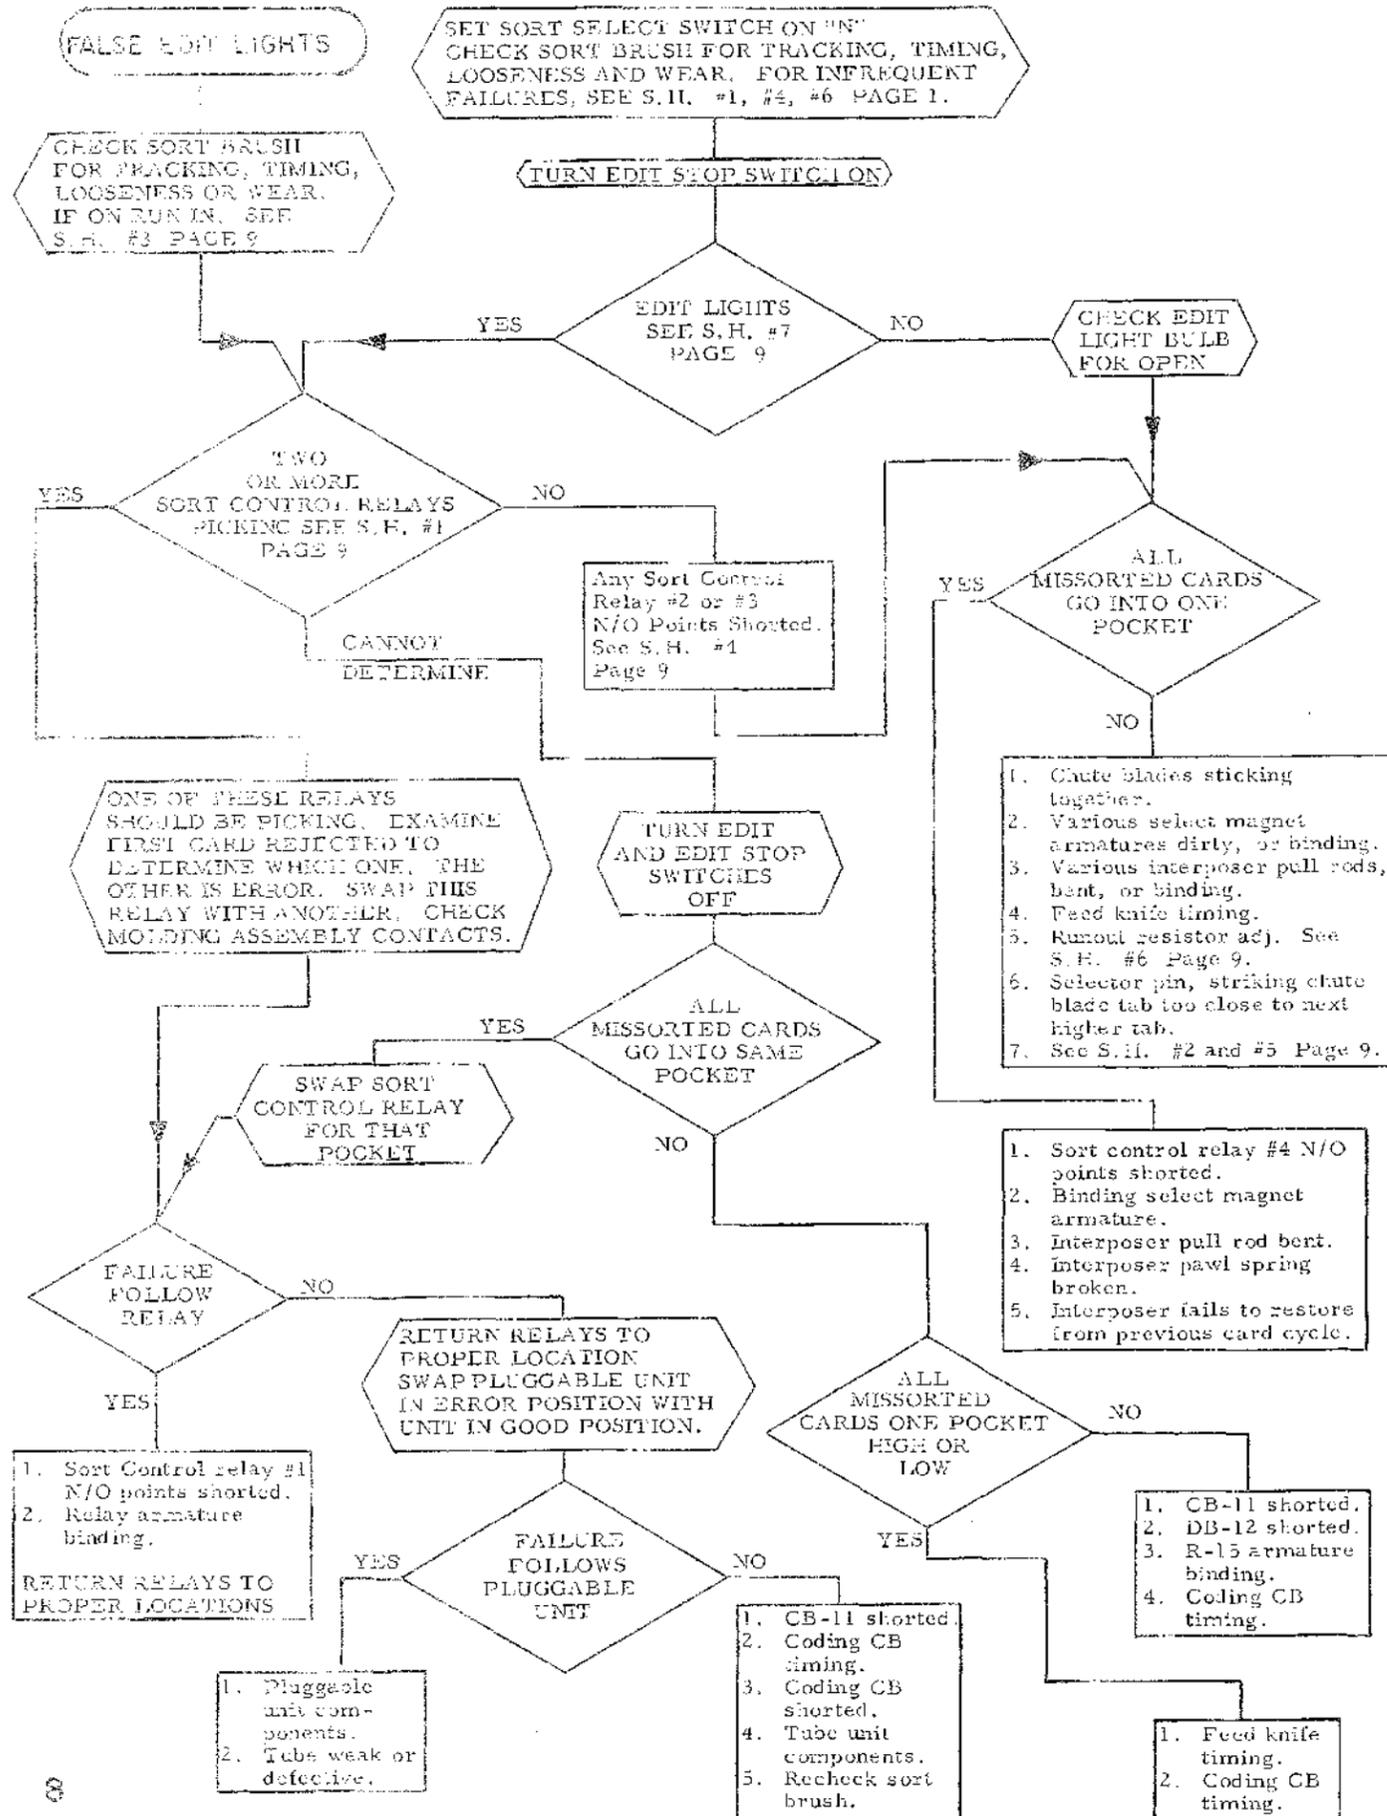
# MISSORTING

## MACHINES WITHOUT ERROR RETENTION

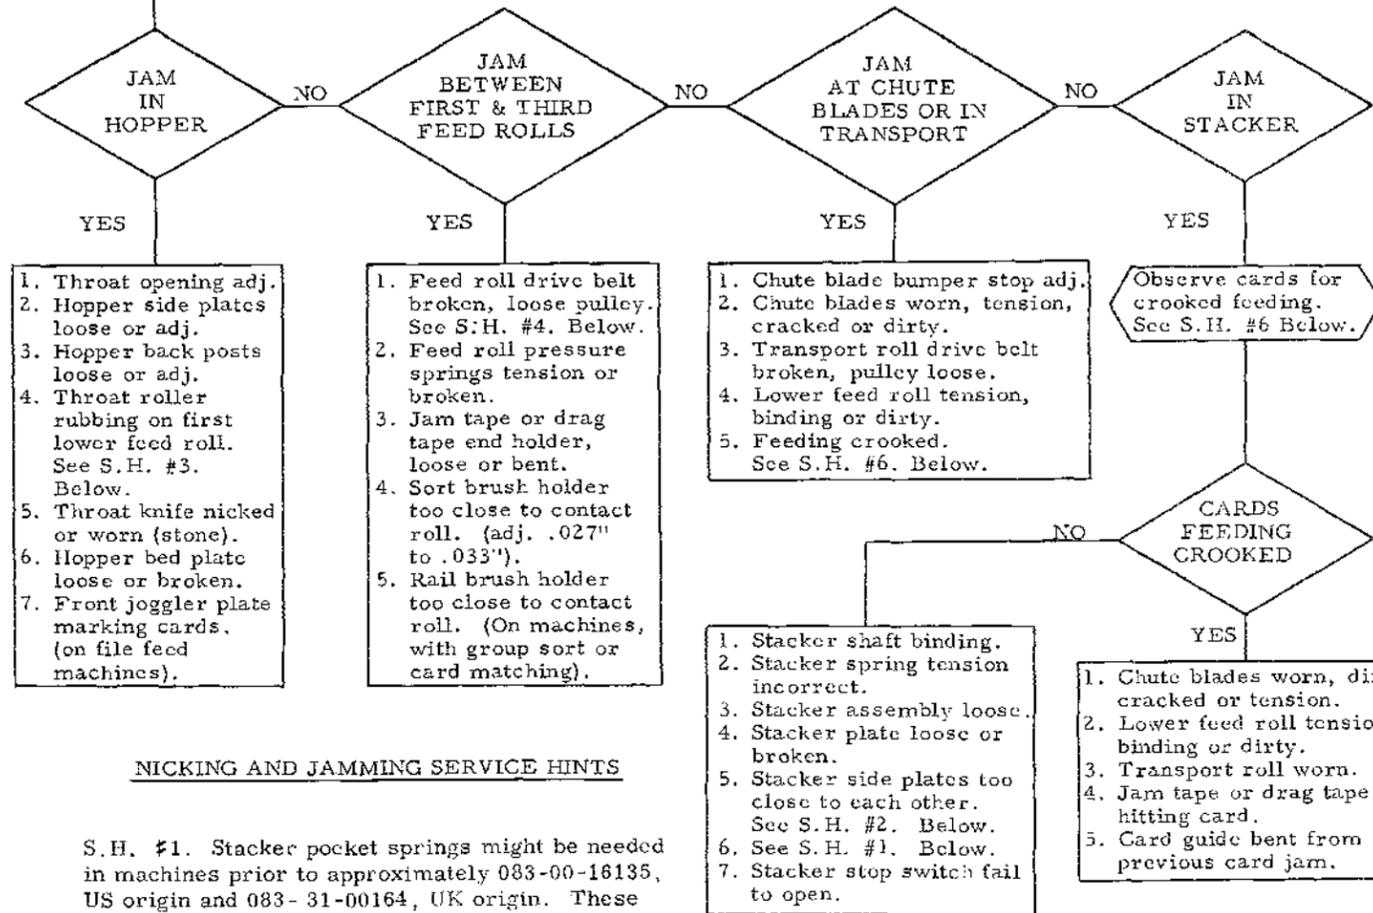
# JAMMING

BE SURE CARDS ARE NOT NICKED, WARPED, OR OTHERWISE DAMAGED BEFORE FEEDING INTO THIS MACHINE.

S.H. #1. Stacker pocket springs might be needed in machines prior to approximately 083-00-16135, US origin and 083-31-00164, UK origin. These springs eliminate uneven stacking and possibly nicking and jamming. See CEM 083 - 12 (3).

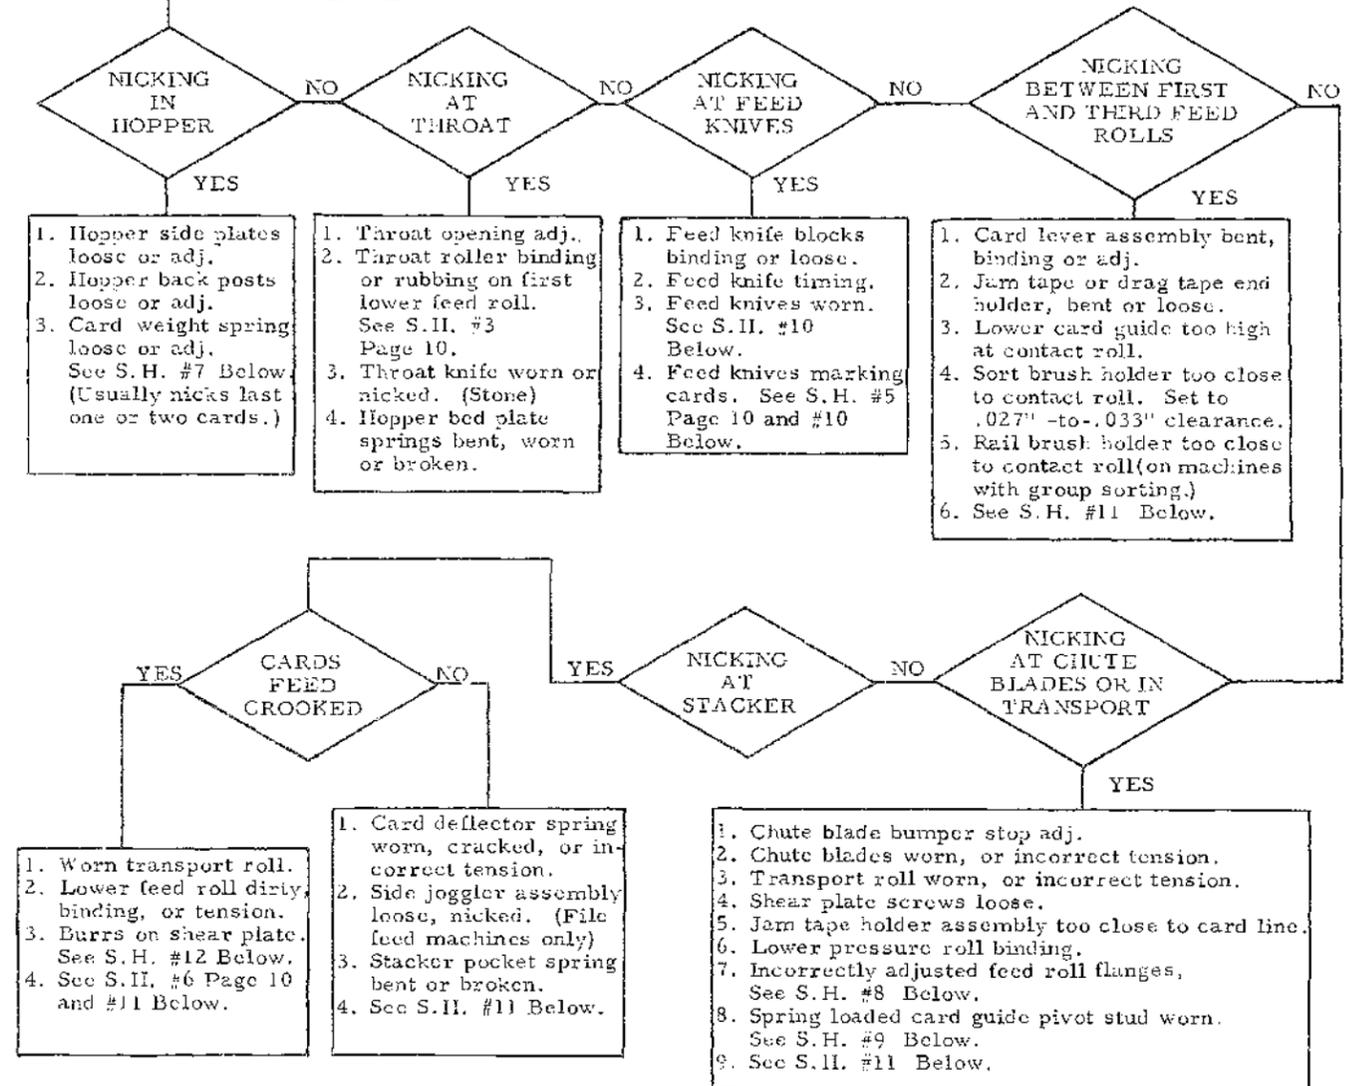
# NICKING

BE SURE CARDS ARE NOT NICKED, WARPED, OR OTHERWISE DAMAGED BEFORE FEEDING INTO THIS MACHINE.

S.H. #7. A loose card weight spring assembly, loose screws, or a maladjusted spring can cause nicking of the last card or two in the hopper. With the card weight out of the hopper, the spring should be adjusted so that the distance between the end sections (which rest on the feed knives) and the bottom of the weight itself is 5/32" plus 1/32 or minus 1/16". Should the spring assembly mounting screw holes be stripped, replace the card weight with P/N 336675 which has been redesigned to include a threaded metal insert, which is used to attach the spring assembly.

S.H. #12. A small number of machines prior to P1 Suffix may contain small burrs on stacker shear plates. This can cause nicking around column 40 on the 9 edge of the cards. Stone these burrs. (CEM 082 - 145(80, 86) Item 1).
